CENTRAL LIBRARY

Investigation Report

Central Library Fire
Los Angeles, California
April 29, 1986

Michael S. Isner

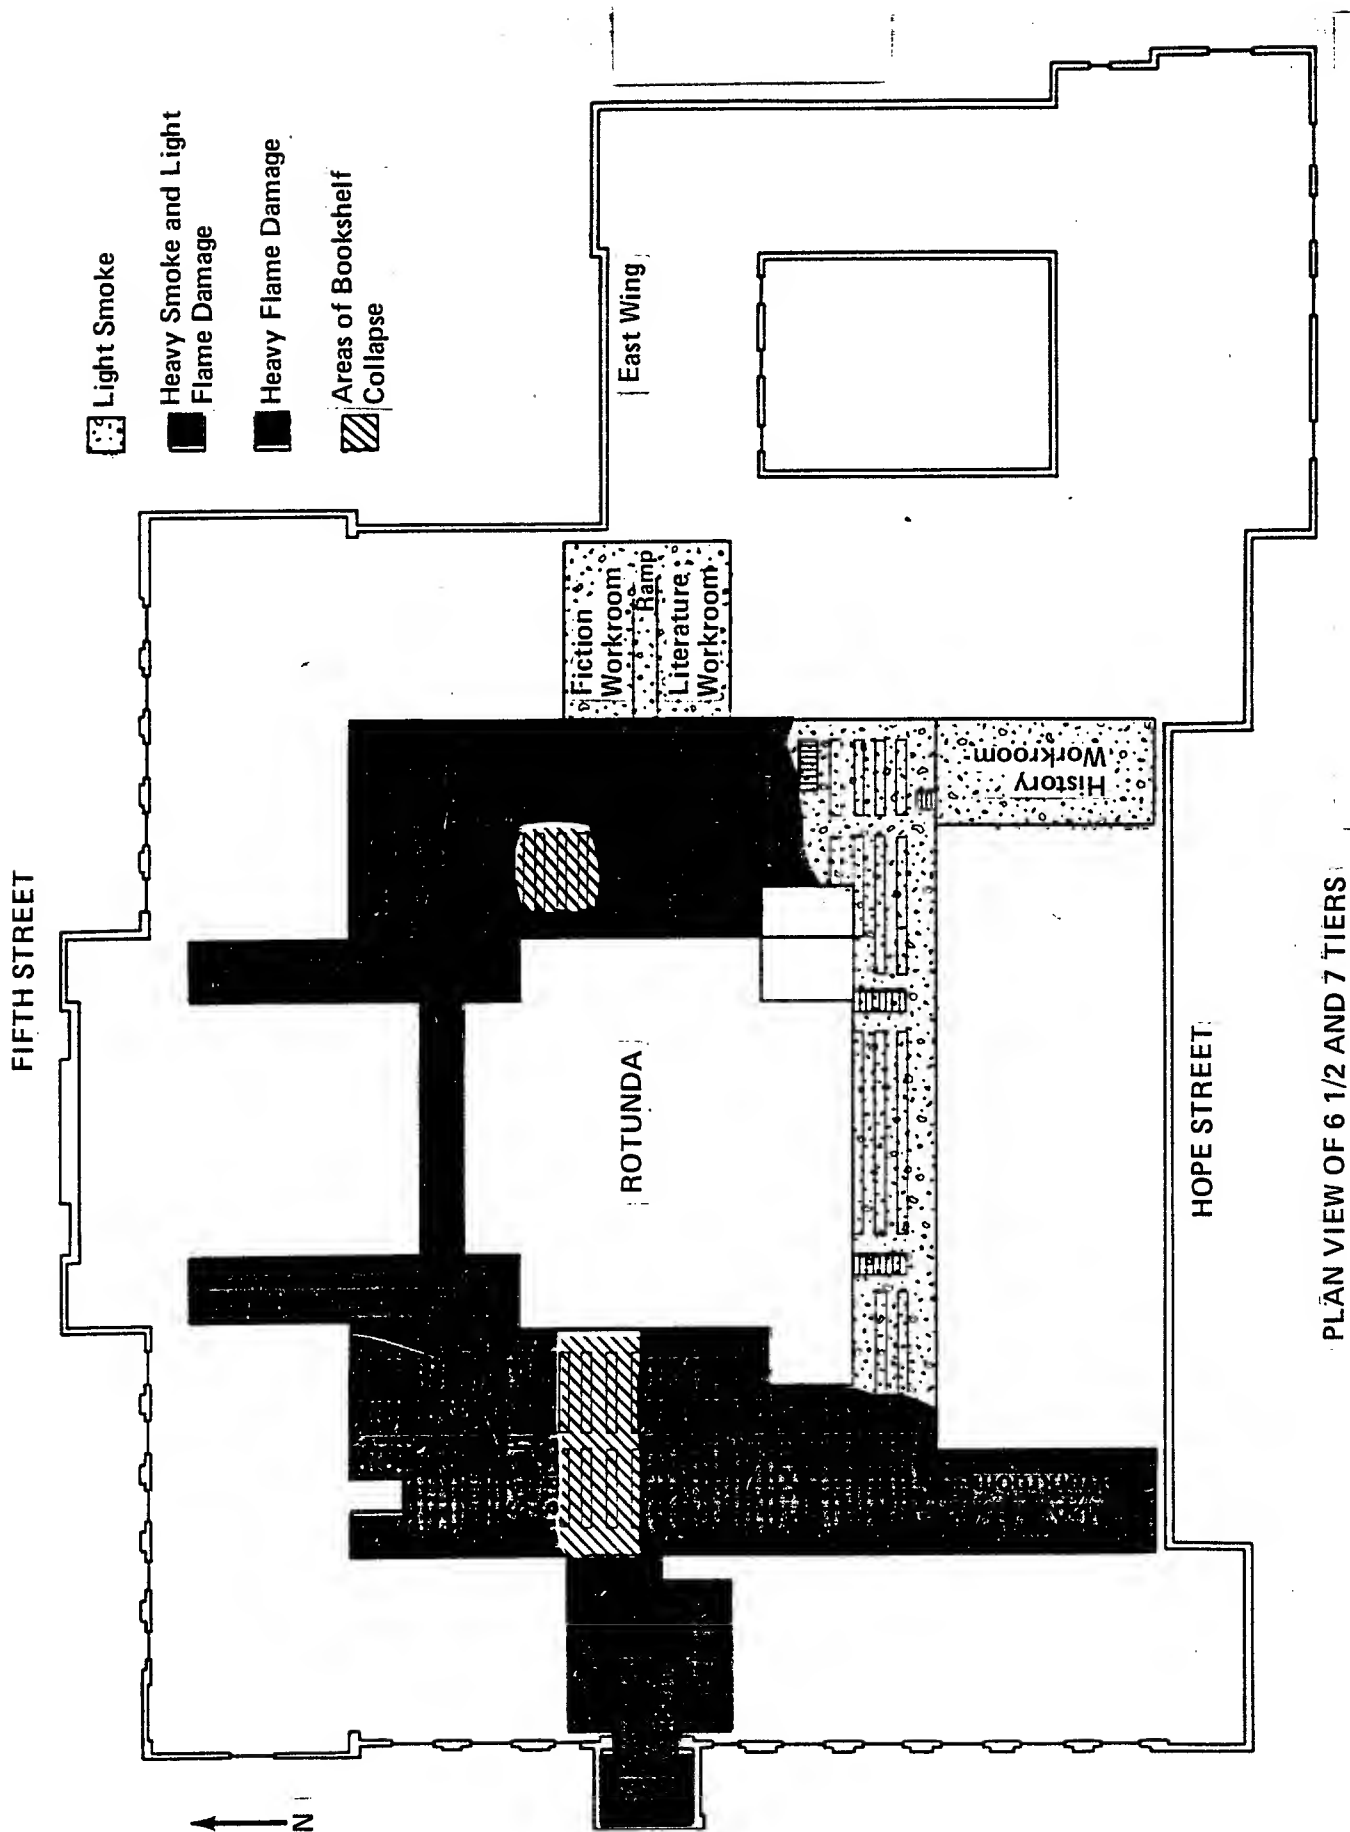
Figure 6

The fire spread up into the tier above. Except for the books in the corner near the stairway (see Figure 6), materials in the 7th tier area directly above the northeast stack were severely damaged by flames or heat. Approximately four rows of bookshelves in this part of the 7th tier collapsed and fell into the 6th tier. The collapse extended only about half the length of the northeast stack.

The fire consumed most material in a dead-end corridor near the northeast stack (see Figure 6). A concrete beam near this corridor had some spalling damage. Only traces remained of the combustible materials that were in the corridor between the northeast and northwest stacks. The 1-inch plaster veneer fell off all surfaces in this corridor and several beams at the west end were severely spalled; a crack in one beam resulted in that member separating from the ceiling/floor slab above. The fire also consumed most combustible materials in the dead-end corridor that was adjacent to the northwest stack (see Figure 6). Once in the northwest stack, the fire caused severe damage and resulted in the collapse of four more rows of bookshelves. This area of collapse, however, extended the full length of the northwest stack (see Photo 4).

The fire involved 7th tier books as far as the southwest stack. The remaining areas of the 7th tier had varying degrees of smoke and heat damage (see Figure 6). Several rooms on the 6 1/2 tier level were damaged by smoke and fire. The Patent Room was gutted (see Photo 5); the Map Room was severely damaged by smoke, and remaining rooms on the 6 1/2 tier received some smoke damage.

PLAN VIEW OF 6 1/2 AND 7 TIERS
